BROOMFIELD HOUSE ENFIELD

THE SIGNIFICANCE OF THE HOUSE AND PARK

The Paul Drury Partnership

July 2009

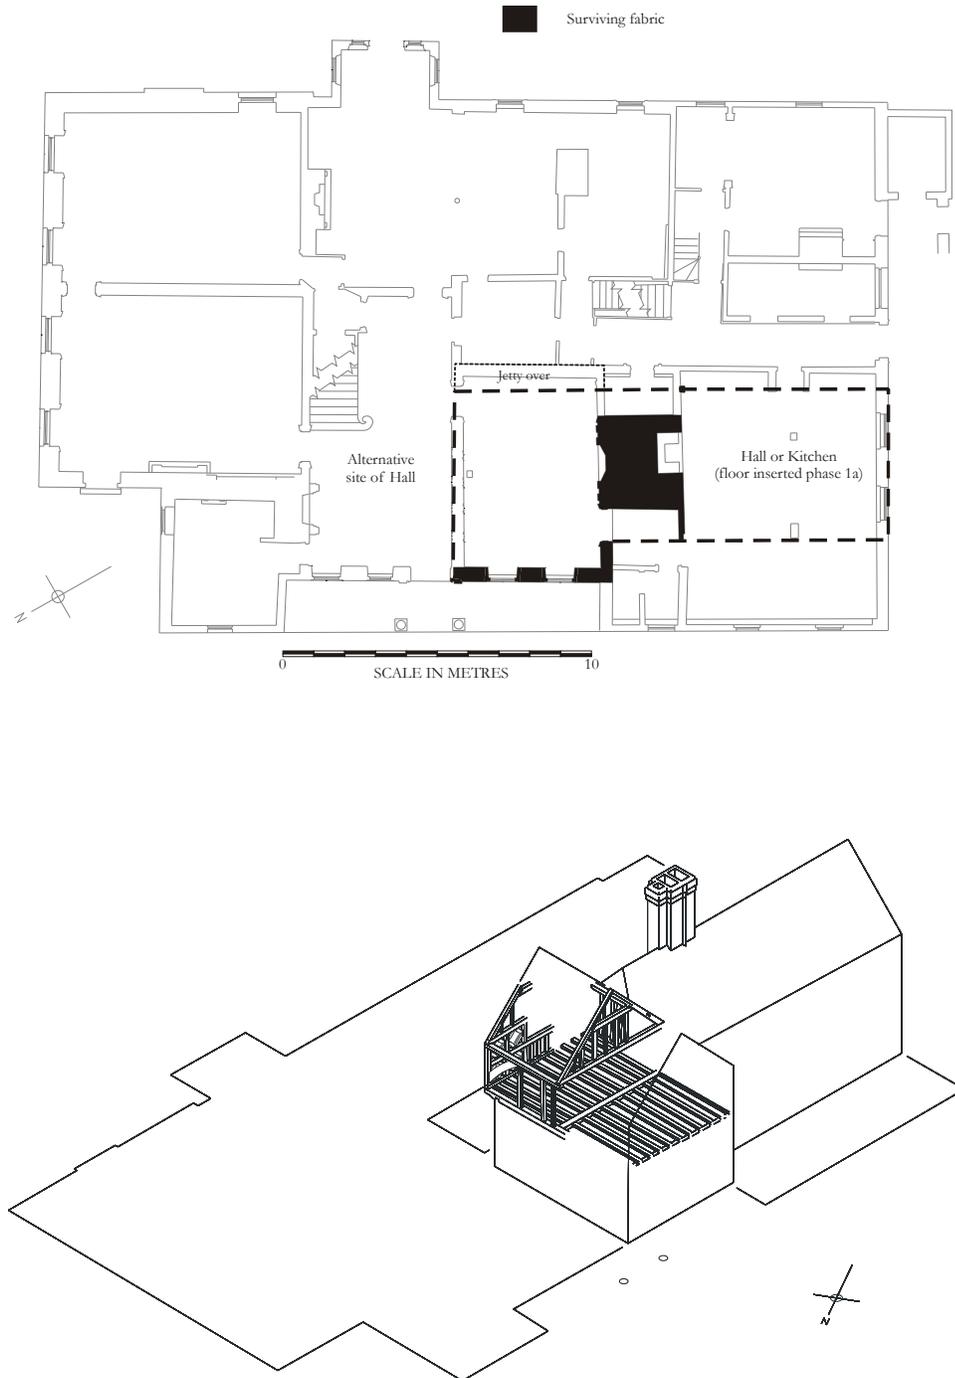
Figure 4: Broomfield House c.1562 (Richard Lea)

- 2.1.1 The earliest surviving parts of the house are fragments of timber-framing for a jettied cross-wing in the centre of the building (rooms G8, F12, F18 & F20). The jettied gable has small square panels with quadrant bracing, infilled with lath and daub, flanking a central window with close studding beneath (figs. 2-4). The roof appears to have had clasped side purlins (now lost) with wind braces. At ground floor level the framing of the west wall of the primary structure survives.

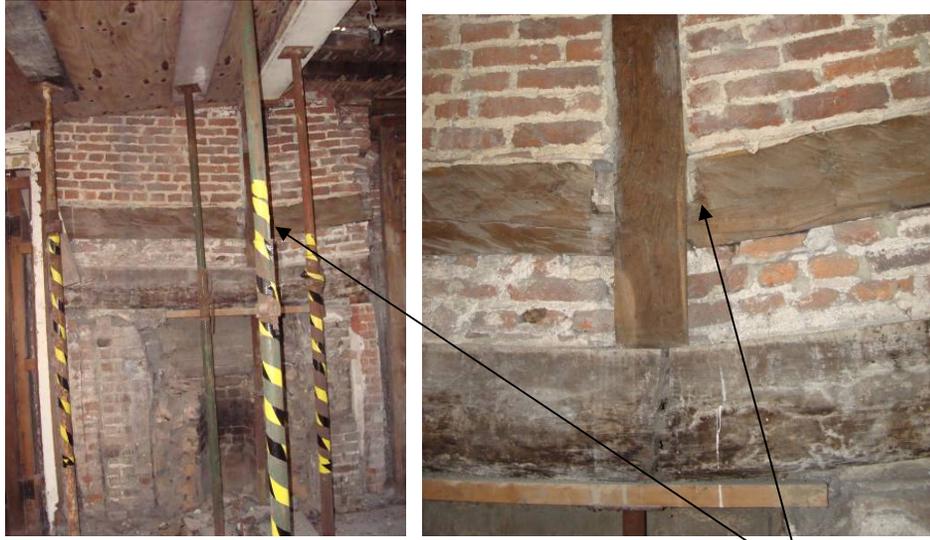
Figure 5: Cross-wing - ground floor chimneystack and detail of empty mortice for original floor structure

- 2.1.2 This cross wing was heated by the extant brick stack on the south side. It is unclear whether the upper chamber was heated, as later alterations have obscured the original form of the stack at this level. At a later date (see phase II below) the first floor of the cross-wing appears to have been raised to increase the height of the ground floor. This involved simply jacking up the entire frame and placing it on a rebuilt, and higher, brick plinth. The original level of the first floor can be seen from the mortice directly over the fireplace, which is thought to have originally held the central spine beam of the first floor (fig. 5).

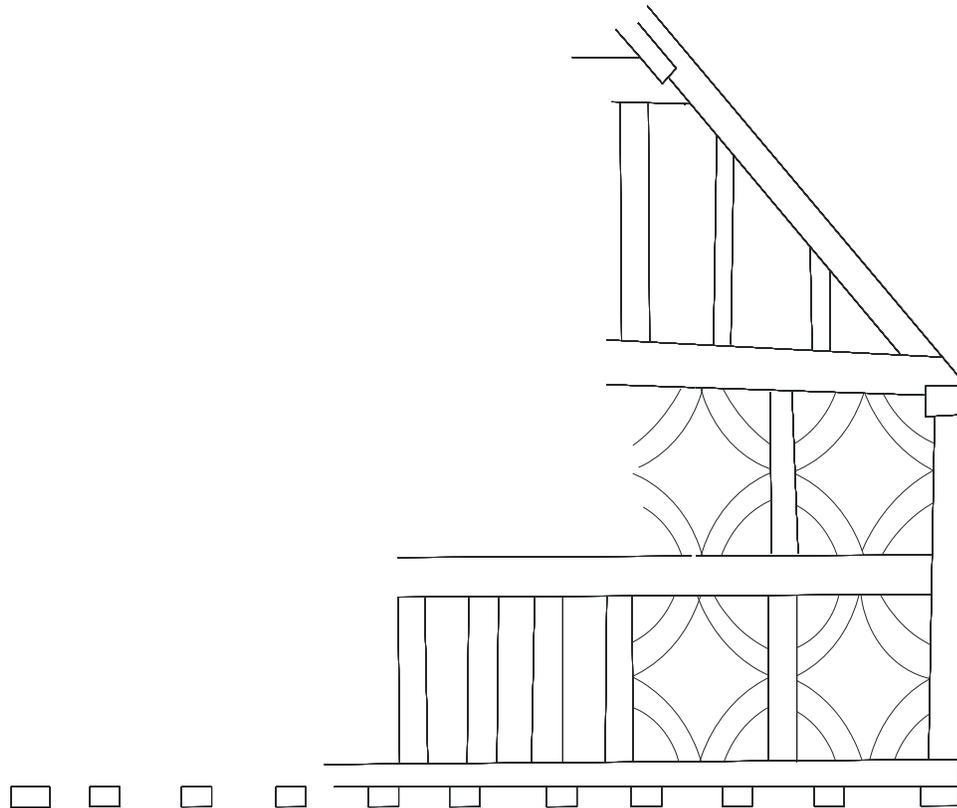
Figure 6: First floor cross-wing, surviving elements of decorative gable

- 2.1.6 Quadrant bracing in squares (fig. 6) is characteristic of early post-medieval buildings in the Midlands, but is rare in the south-east, although it has been recorded in Rye, Sussex. The presence of this decorative bracing on the east side implies that the principal frontage was on the east, rather than to the west as is currently the case.

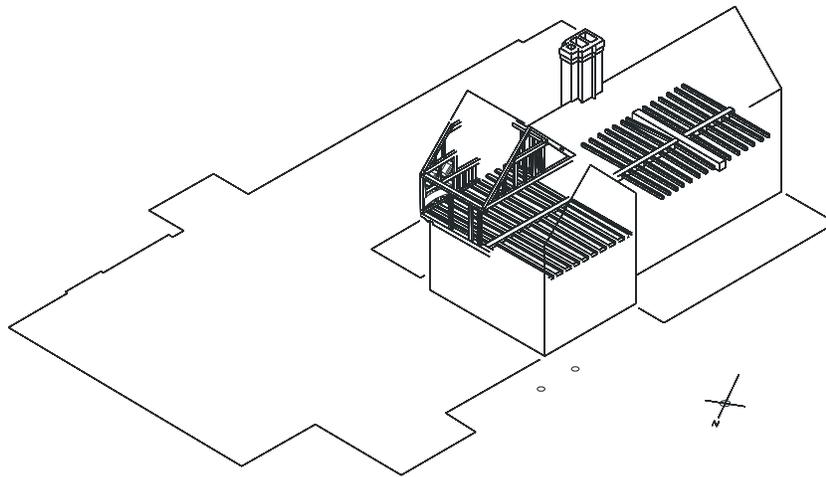
Figure 7: Broomfield House in phase Ia

- 2.2.1 The next phase of development of the building was the insertion of a first floor into the possible hall/kitchen G12 (fig. 7). The framing of this floor is of a different character to that of the cross-wing, suggesting that it was carried out at a later date.
- 2.2.2 This phase cannot be securely dated, although it clearly predates phase II (see below). The character of the joists, particularly their square cross-section, suggests a 17th century date.

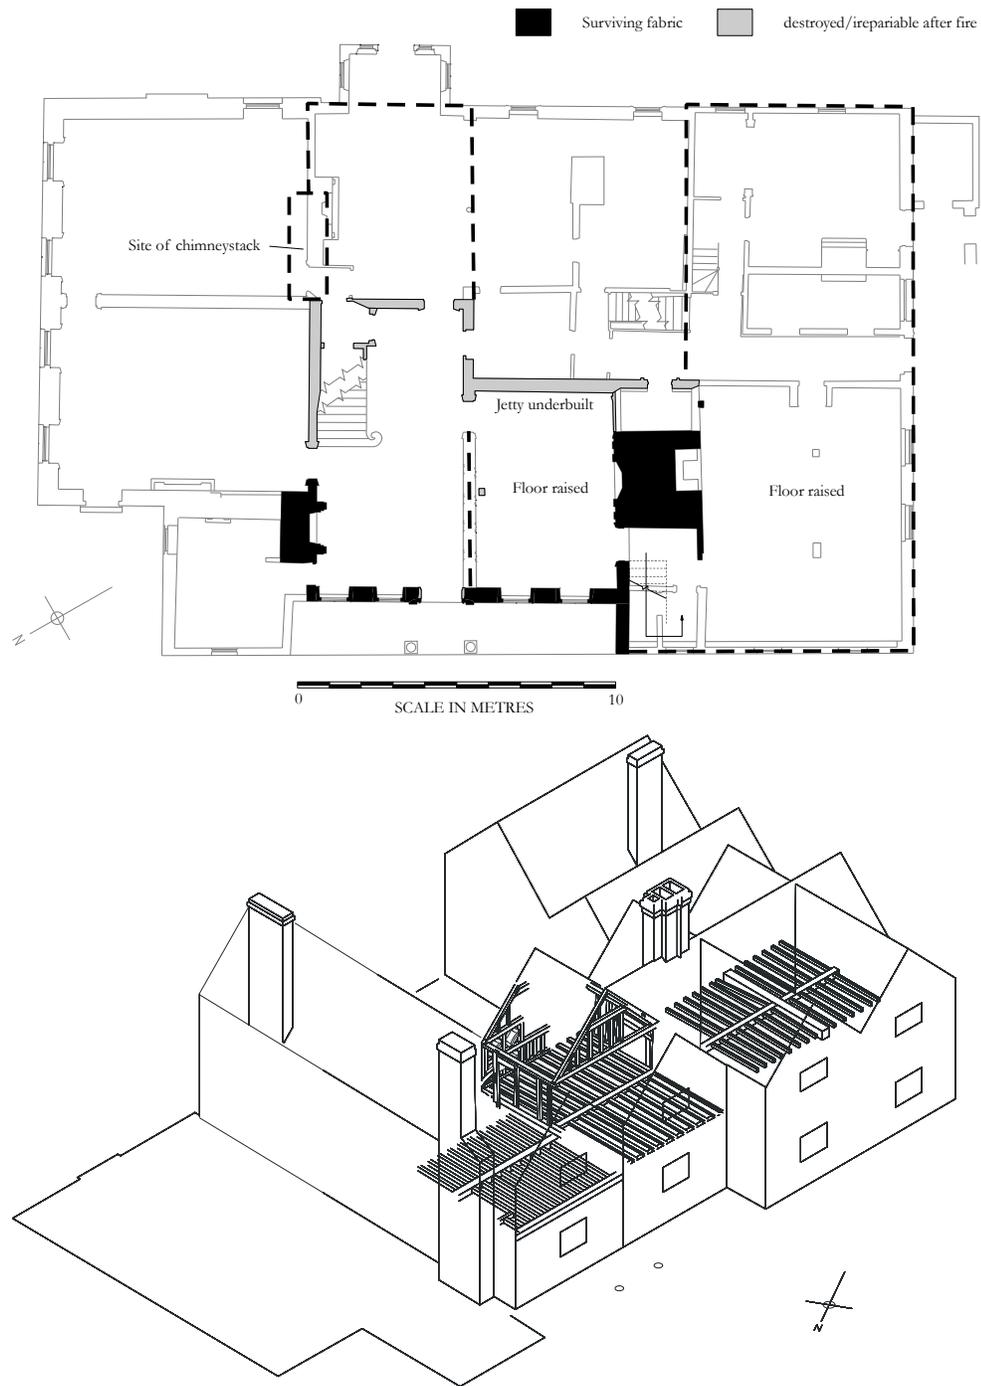
Figure 8: Broomfield house c.1600 (Richard Lea)

2.3.1 There are signs that Broomfield was extensively altered during the early part of the 17th century (fig. 8). The floors of the phase I cross-wing and phase Ia hall were probably raised at this time, as the head of the post inserted to carry the spine-beam of the cross-wing floor has carved scrollwork decoration of early 17th century character (fig. 9). Likewise the

- 2.3.3 The presence of a fully-framed floor and fragments of wall plate to the north of the cross wing (G4/G5-F5/F19) suggest that a two storey gabled wing was added to this end of the building in the 17th century. This was built above a brick lined cellar and heated by two external stacks on the north side (fig. 8).

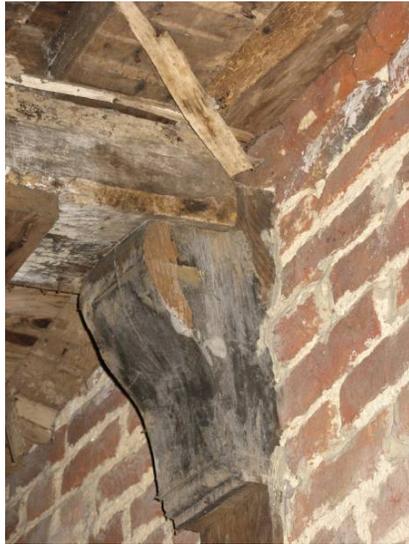
Figure 9: Inserted scrolled bracket carrying cross-wing floor

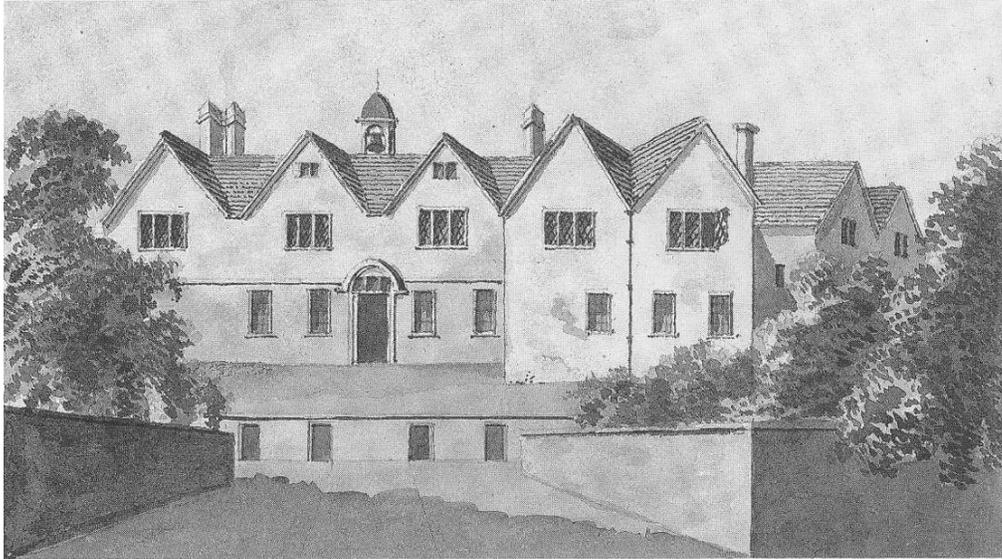
- 2.3.4 The 'hall' (G12) appears to have been extended at this point, with the addition of gabled projections on the west. These are shown in a drawing of c.1800 (fig. 10) and have since been replaced by later softwood timber framing. However, the dwarf walls under this framing are of the same character as the dwarf walls of cross-wing. Similar fabric in the area now occupied by G6, G10, G11 and G14 also implies that the house was also extended to the south-east. This may have been one of the two gabled projections at the south end of the house shown on the c.1800 watercolour.

Figure 10: Watercolour of the west elevation of Broomfield House c.1800

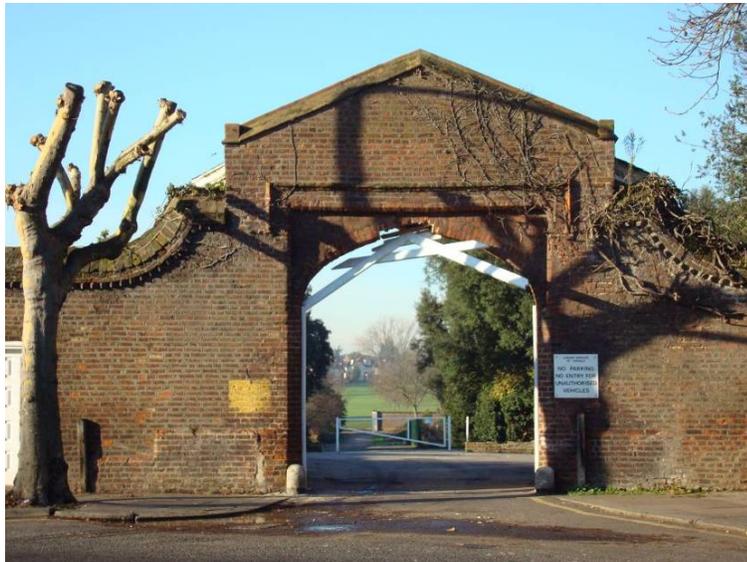
Figure 11: 16th or early 17th century entrance

2.3.6 The house appears to have acquired a formal garden by the early 17th century. Part of the east wall of the park, including the Tudor style four centred arch in the east wall, and the pedestrian gate at the south end of this wall, are 16th or early 17th century in character (Figs. 11 and 12). The simple nature of these walls, and the rebuilding of the gable over the gate in the 19th century, make them impossible to date closely. The walls of the stable yard and the wall linking the house to the park wall are probably of similar date. This implies the enclosure of the immediate grounds and therefore some form of formal garden. The ponds to the west of the house may have begun life in the medieval or Tudor period as fish ponds.

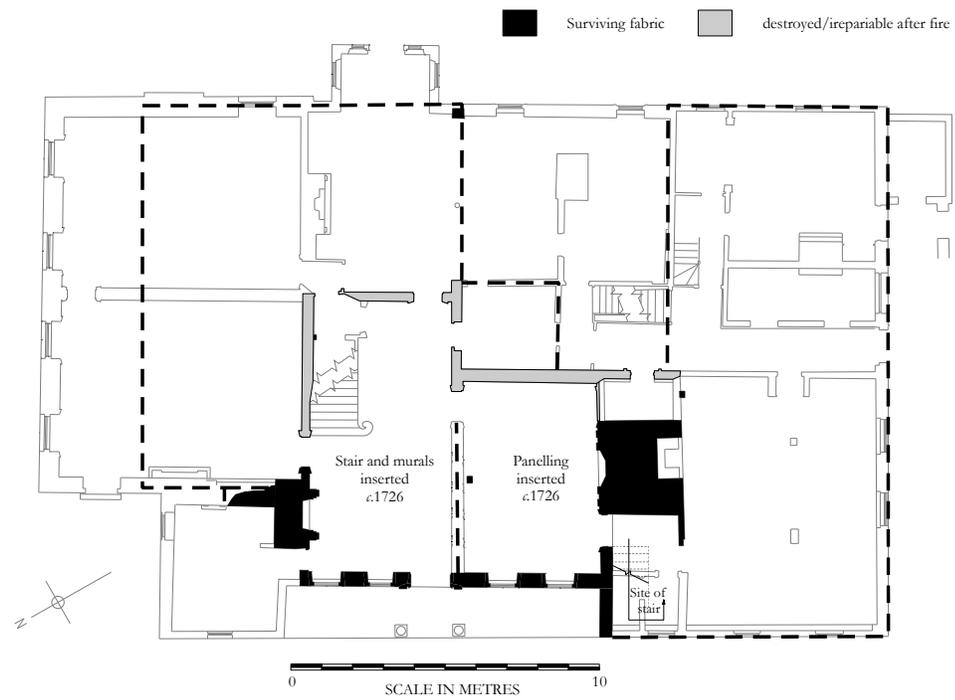
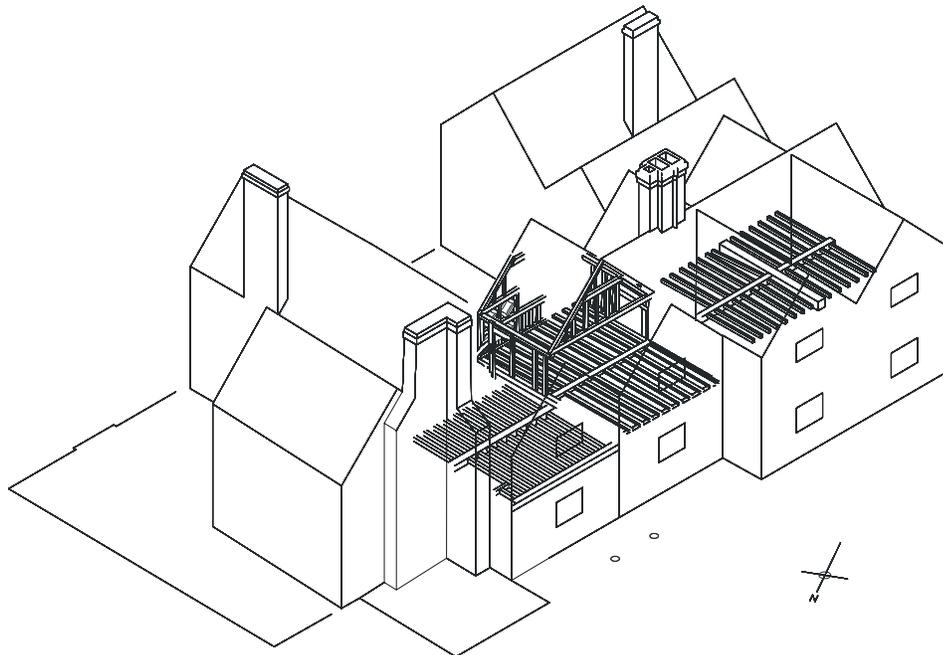
Figure 13: Broomfield house in the later 17th century (Richard Lea)

2.4.1 The next phase of works consisted of additions to the north and east (fig.13). All that survives from this phase are the basements (B1, B2, B5 and B6) and extensions to the phase II chimney stack heating the north

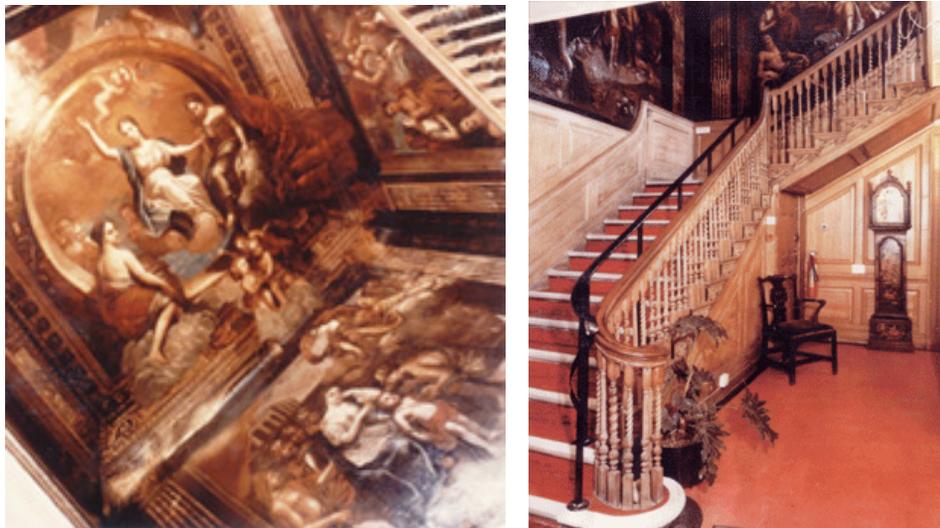
Figure 15: Main stair and murals before the fires

- 2.5.3 The lining of G4 and G8 with oak panelling, the strengthening of the timbers of the floors above these rooms and the blocking of the door at the east end of the north wall of G4 are also probably contemporary with this phase. At first floor level, the mural scheme allowed for doors to the east (presumably to the first floor of the phase II cross wing) and west, and a window to the south, to what is now a light well, and may well still have been an open courtyard at this point. As there are no windows to the north, the murals must have been very poorly lit.

- 2.5.4 These changes established G4 as the main entrance hall, a function it may not have had before this date, and suggests that the building was ‘turned around’ at or by this point, with the west elevation, formerly the rear of the building, becoming the main façade.

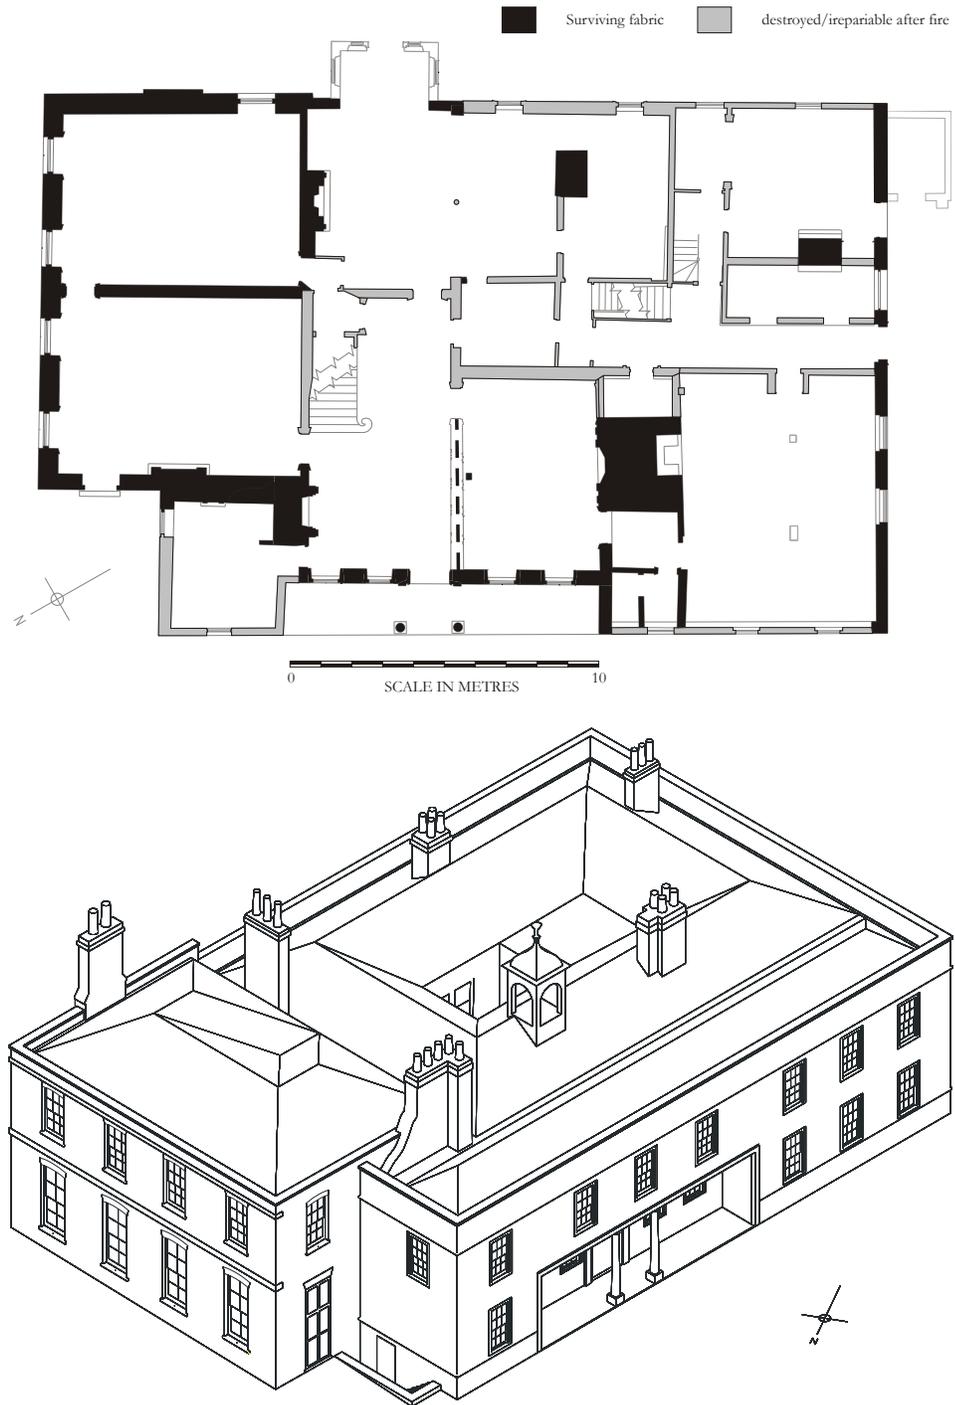
Figure 18: Broomfield House in the early 19th century

2.6.1 Between the publication of the Edmonton enclosure map *c.*1800 and the first edition of the Ordnance Survey map of 1867 there was a radical transformation of Broomfield, from a picturesque many-gabled house to a

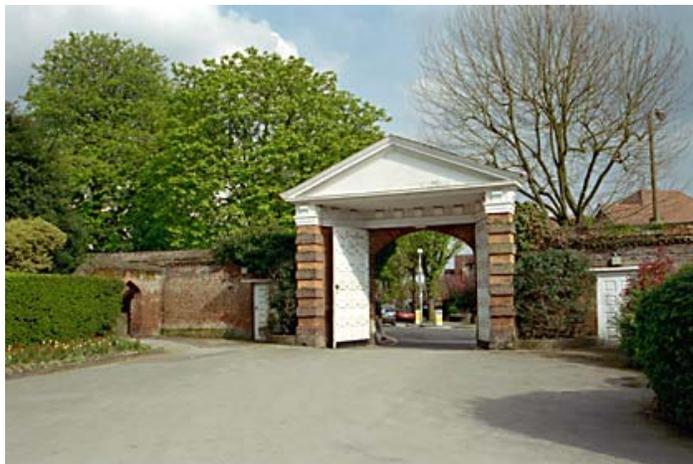
Figure 20: Entrance gate, inner face

- 2.7.3 Some alterations were also made to the park. The eastern part of the park was used as a gravel pit by 1867, but appears to have fallen out of use by 1896.¹² Broomfield Farm, the home farm to the south of the park, was well established by this point. The classical portico on the inner side of the Tudor entrance gate appears to have been added between 1867 and 1896 (fig. 19).¹³ A copy of the latter map was annotated with new roads and sewers, one of which cuts through the buildings of Broomfield Farm.

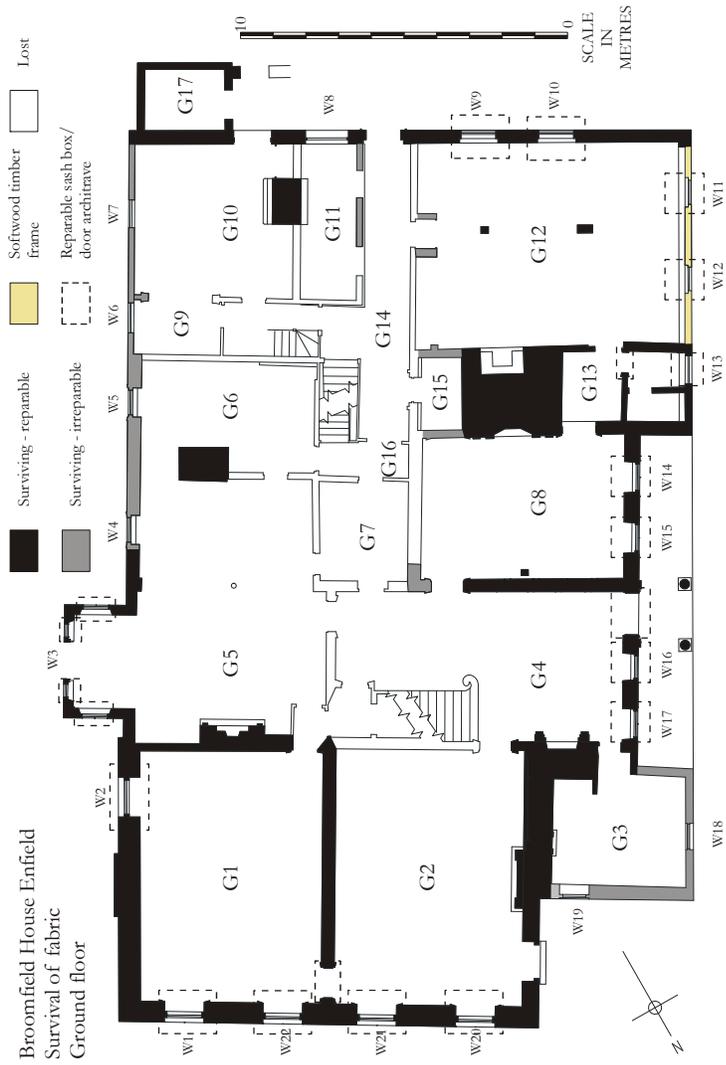
Figure 23: Survival of fabric, ground floor level
(scale 1:200)

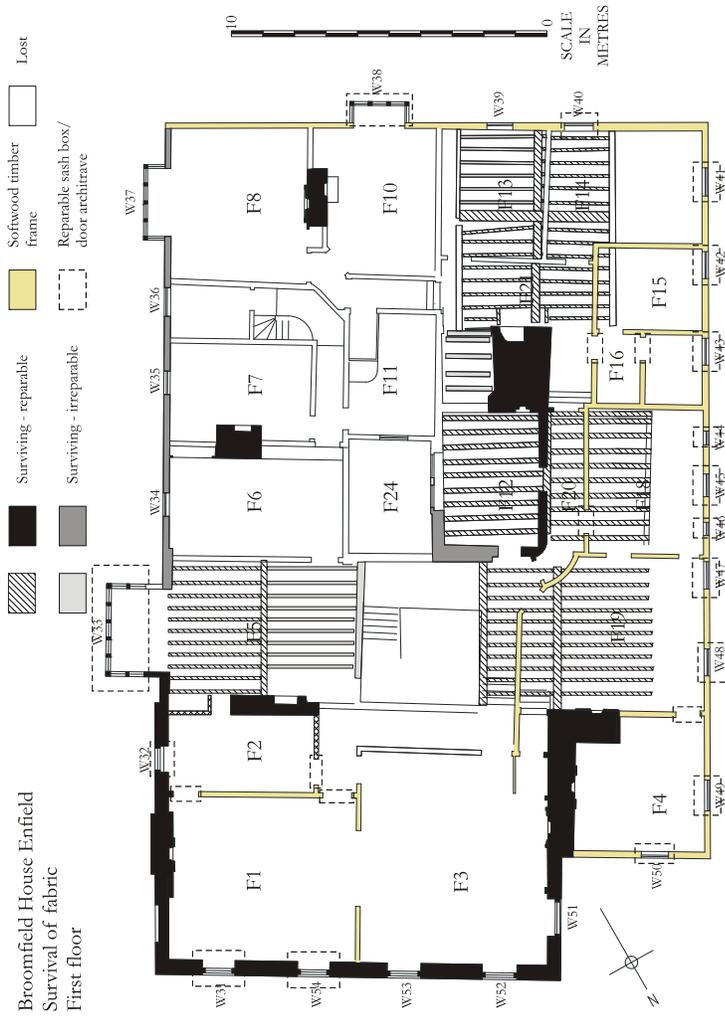
Figure 24: Survival of fabric, first floor level
(scale 1:200)

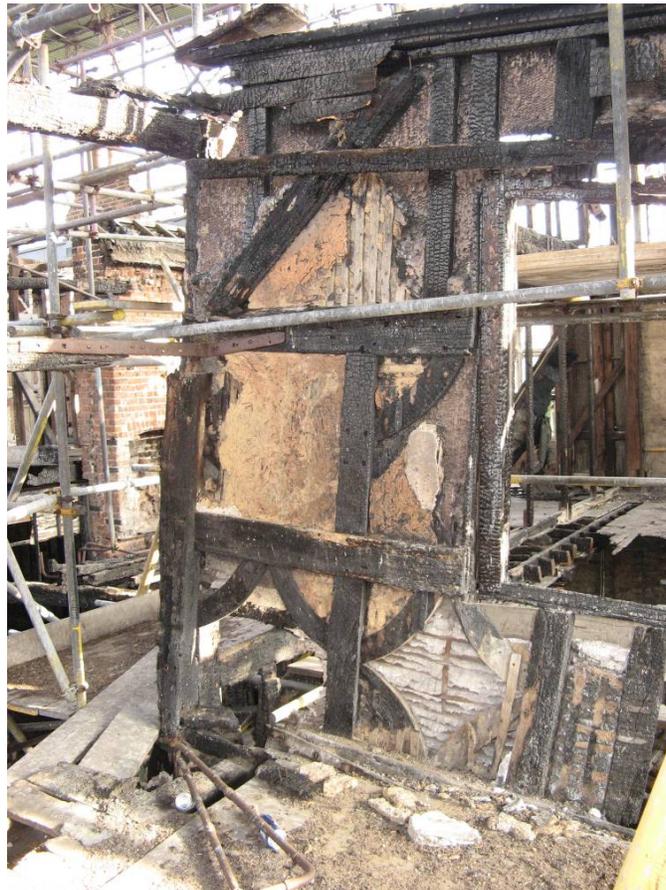
3.1.2 While the decorative framing on the east gable wall has been damaged by fire, remaining timbers are only surface-charred, largely internally, and could be incorporated into a rebuilt frame. While a relatively large number of timbers survive from this phase, they are essentially fragments that could be incorporated into what would be a largely new building, rather than forming a structurally coherent unit that is capable of repair.

Figure 25: F12 cross-wing, remains of framing

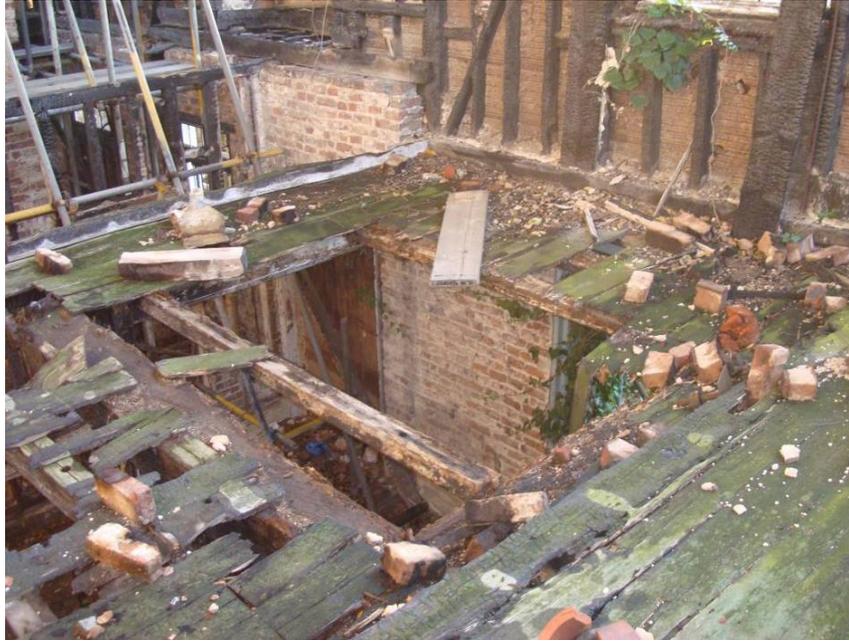
- 3.2.1 All that survives from this phase is the floor inserted into the 'hall'. This survived the fire largely intact, but the southern-eastern part has since rotted away. Around a quarter of the fabric that survives in situ is in a very poor condition due to rot and is unlikely to be salvageable.

Figure 26: G12 Phase Ia floor

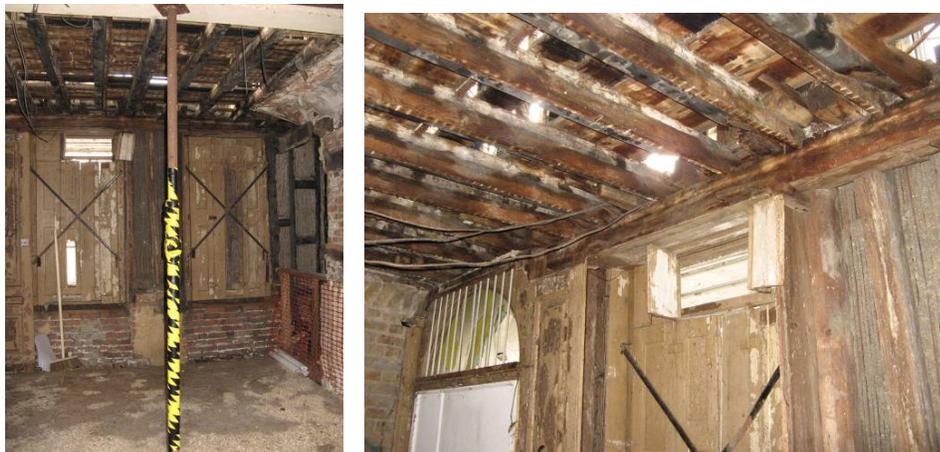
- 3.3.1 The earliest part of the cellar survives intact from this phase (B4/B5), as does the floor structure (F5/F19 – though the western half of the floor frame in F5 has been irreparably damaged by fire), the west wall and chimneystack of the north wing (G4), and the plinth walls on the west side of the ground floor of the cross-wing (G8). Scattered fragments of the mid rails and wall plates of the north wing also survive.

Figure 27: G4 17th century wing, ground floor

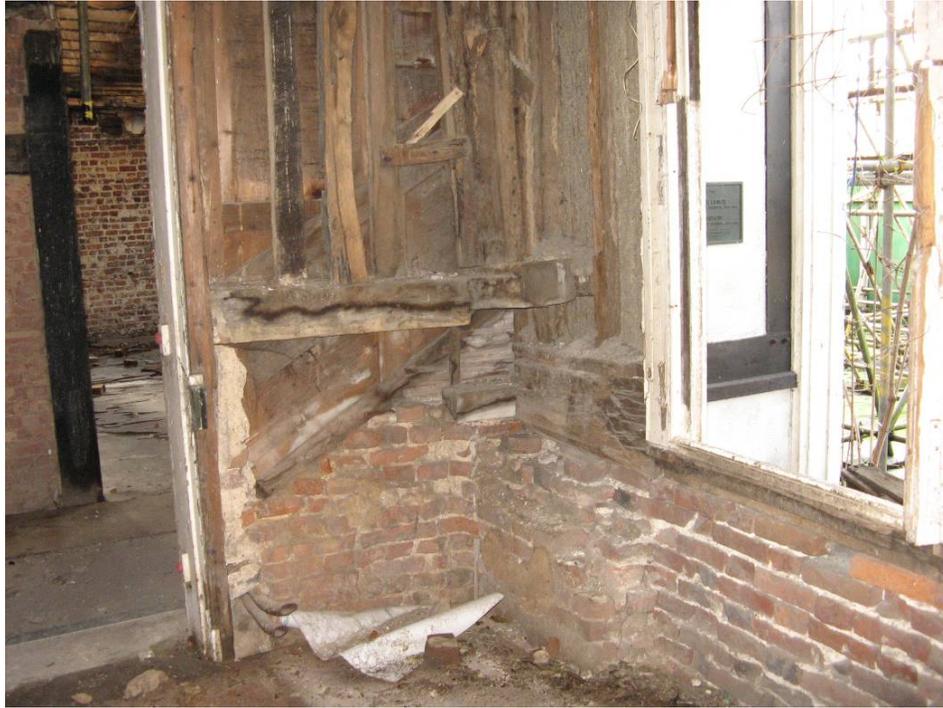
- 3.4.1 Survival of this phase is limited to parts of the cellar, the extension to the northern chimneystack and the dwarf walls supporting the timber-framed ground floor on the western face of the building.

Figure 28: G8 Phase III plinth

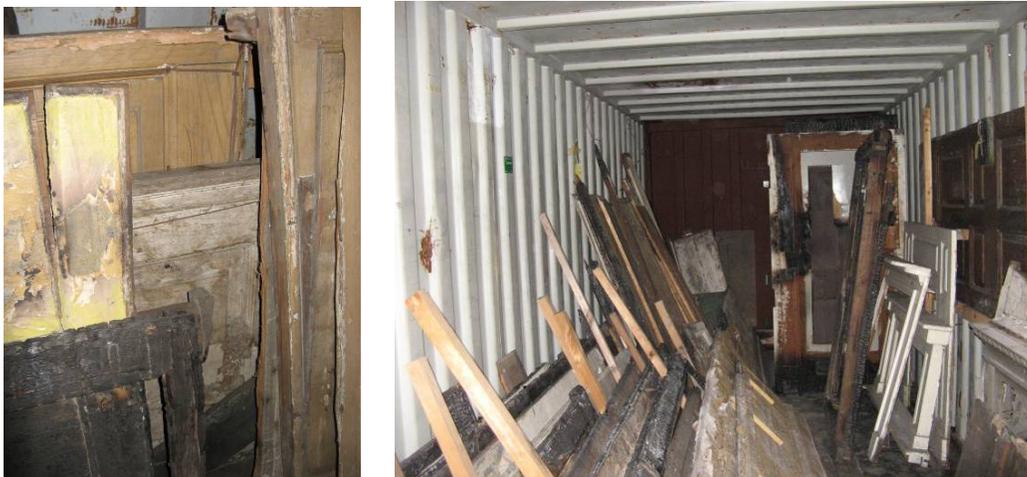
3.5.3 Panelling from G4 and G8 was removed and stored in containers in the stable yard. The extent of survival was recorded by Donald Insall Associates in 1994. They indicate that approximately 70% of the panelling in G8 and 85% of the panelling in G4 survive. A recent inspection suggests that this material has not deteriorated since it was stored. The majority of the balusters, and part of the handrail for the main staircase, also survive and are stored in the basement of Southgate Town Hall. It would thus be possible to reconstruct these rooms in their pre-fire form. It should be noted that the containers in which these are stored are beginning to leak as the roofs rust through, and their contents are thus now at immediate risk.

Figure 29: Stored architectural fragments

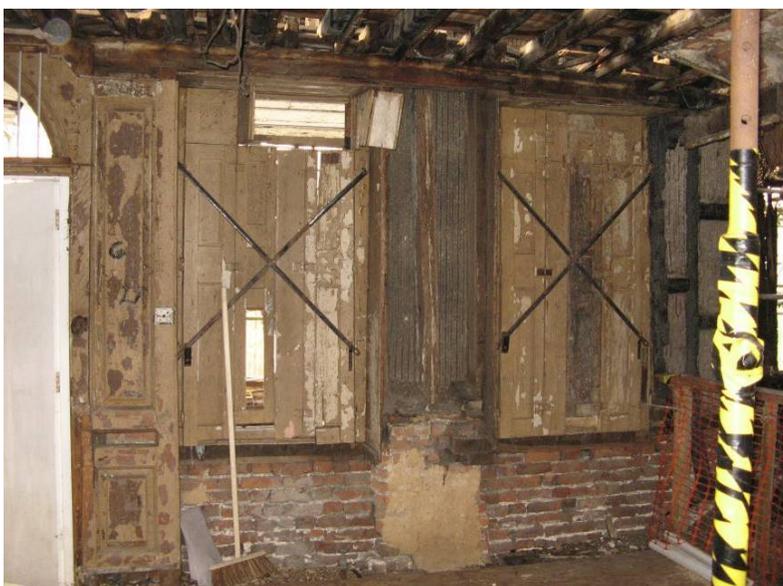
- 3.5.1 Surviving elements from this phase are mainly associated with the fitting out and decoration of the building rather than its structure. In situ, only the windows and doorway in rooms G4, and the panelling and framing around the former stair, survive intact. The architrave around the doorway between G4 and G8 and the door to G15 survive in situ but have been severely damaged by fire. Shutters in G8 have been removed from their boxes but remain loose on-site.

Figure 30: G4 18th century joinery in situ

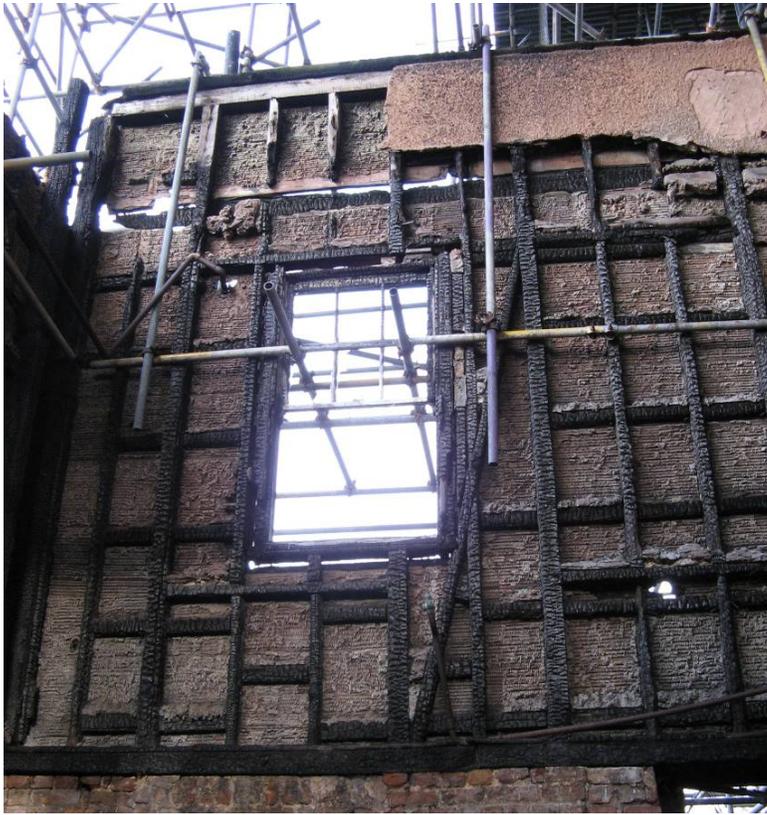
Figure 31: F4 fire damaged timber framing

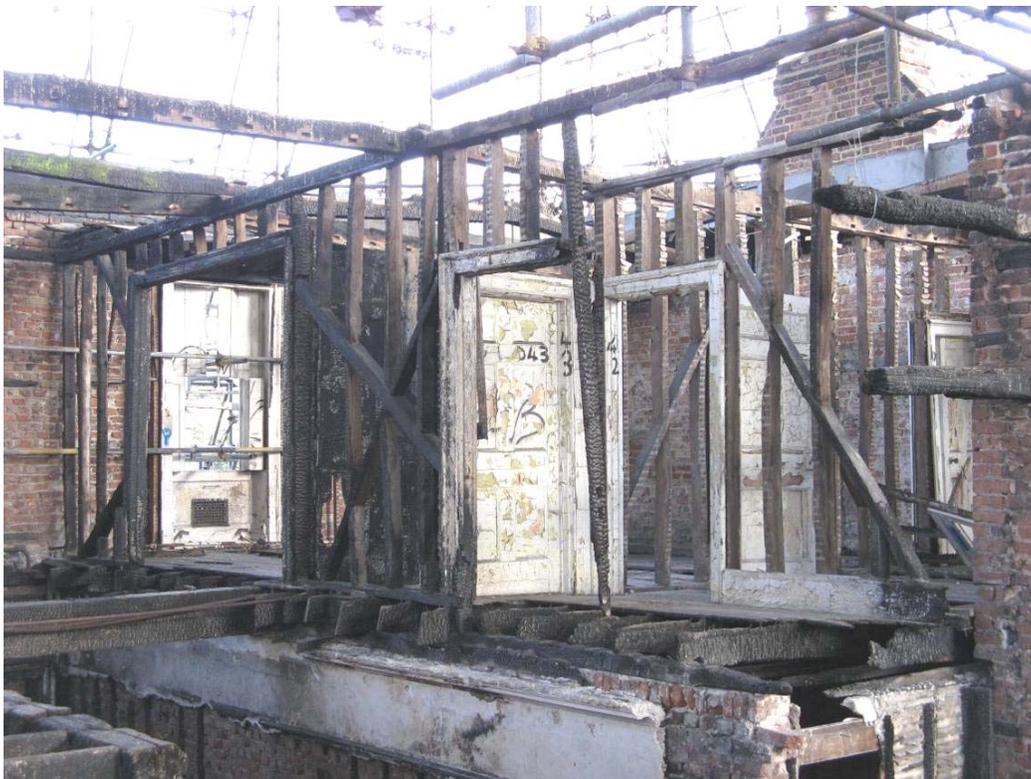
Figure 32: F1 internal partitions

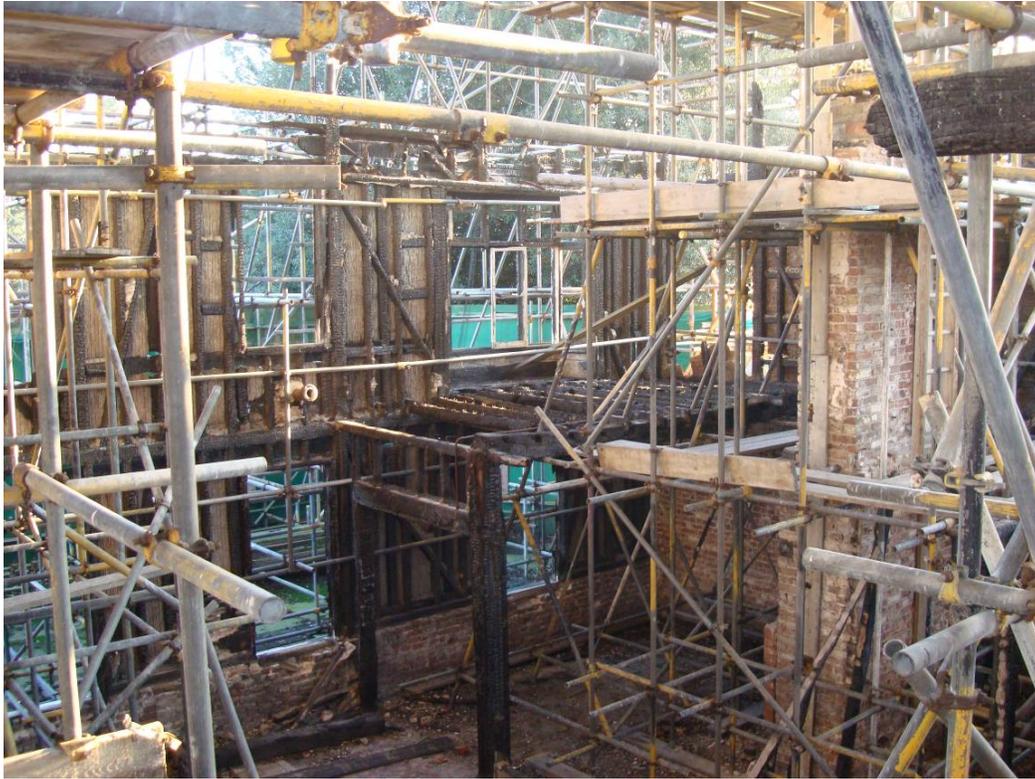
Figure 33: Interior, fire damage

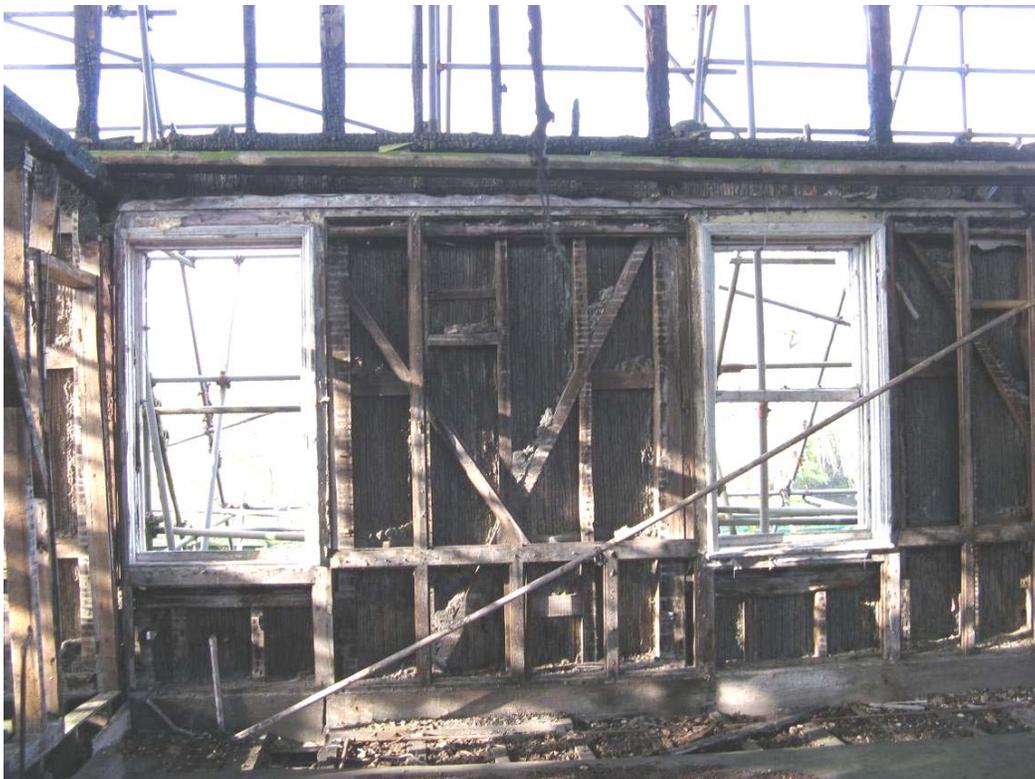
Figure 34: F14, undamaged timber framing

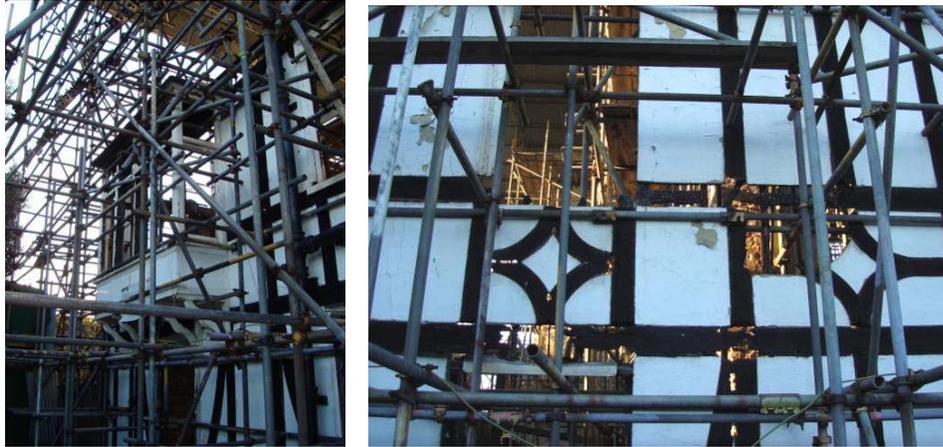
- 3.7.1 Works from this phase are limited to the addition of bay windows and a small single storey extension at the south end of the building, and the lincrusta friezes in G1 and G2. Of these, the bay at the south end of the east wall has been damaged beyond repair, while other elements could be repaired.

Figure 35: Bay window, east wall, south end/ false framing

- 3.8.1 The expanded metal lathing, render and false half-timbering associated with this phase survive, even though the timber frame behind, at least on the eastern side, has been irreparably damaged by fire. This fabric would not survive the structural interventions necessary to repair and restore the building.

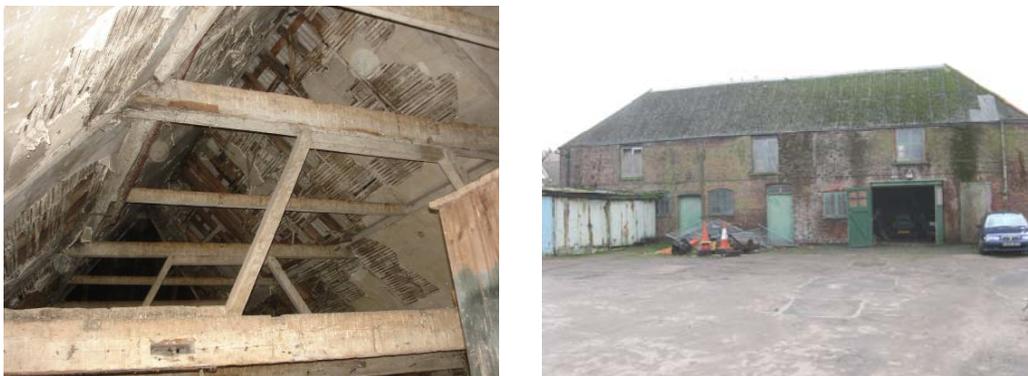
- 5.1.1 The walls of the stable yard are 16th century in character, but the stable block itself is rather later. The Edmonton enclosure map indicates that the stables post-date 1801, and replaced an earlier stable block on the site of the current public toilets. The map (fig. 19) shows two buildings in the stable area that have now disappeared. As it appears to be a generally accurate representation of other buildings in the area, it is probably a reasonably accurate depiction of the stable site. The structure of the building is consistent with an 18th or early 19th century date, and is probably contemporary, or nearly contemporary, with the expansion of the house in the 1820s. It is a simple two-storey rectangular structure with a hipped roof.

- 5.1.2 As built, the ground floor was probably divided into stalls and loose boxes, with a hayloft above. This is suggested by blocked doorways for additional doors at ground level and ventilation slits at first floor level. Much of the building is constructed from reused materials, presumably reclaimed from the house following its reconstruction in the early 19th century. The first floor incorporates a c.17th century floor frame; many of the bricks are narrow and irregular, and probably date from the later 16th or 17th centuries. The roof, a relatively simple side purlin affair, makes use of older timbers for the tie-beams, which have mortices to receive binders for ceiling joists, and many other timbers have been reused in more or less their original layout. Part of the 16th or 17th century park wall is incorporated into the east elevation of the stable. The surviving stalls and fittings appear to be late 19th century in date.

Figure 36: The stables, roof and north elevation

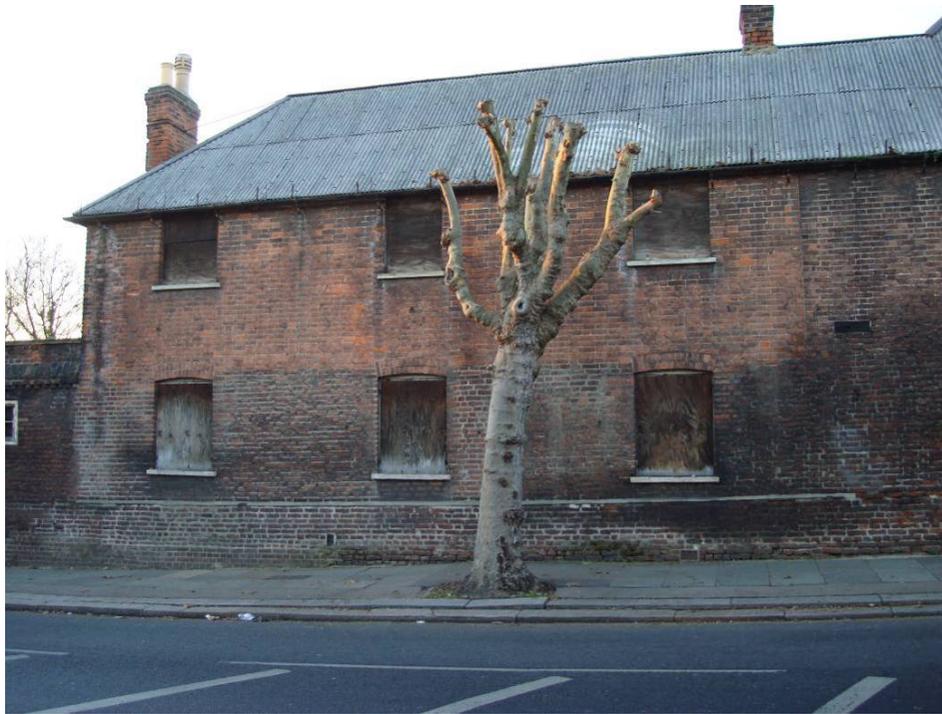
- 5.1.3 The stables were extensively expanded before the publication of the first edition of the 25th Ordnance Survey map in 1867. There were single and two storey additions to the rear, again incorporating the 16th century boundary wall. The fenestration on the north (principal) elevation was also altered. The simple interior fit-out of the building is probably

Figure 37: Mid-19th century stable extension
